**CITY OF CHESTERFIELD  
PLANNING AND PUBLIC WORKS COMMITTEE**

**A. Annual Pavement Condition Report**

This annual Concrete Pavement Manual focuses on the City's concrete roadways and aims to assist Staff with budgeting, project planning, maintenance prioritization, and long-term infrastructure preservation. This report contains a detailed analysis of the City's concrete pavement inventory, inspection methodology, current conditions, historical performance, and future budget scenarios.

The City of Chesterfield's (City) pavement system includes approximately 184.3 miles of publicly maintained roadways. The purpose of this Report is to provide an analysis of the City's concrete pavement system. The analysis will include the following sections: pavement inventory, inspections, and ratings (type, classification, age, condition, quantity); historical pavement condition and spending; pavement condition prediction; future budget scenarios and condition implications; and a summary. This Report will be updated annually in advance of the City's annual budget process.

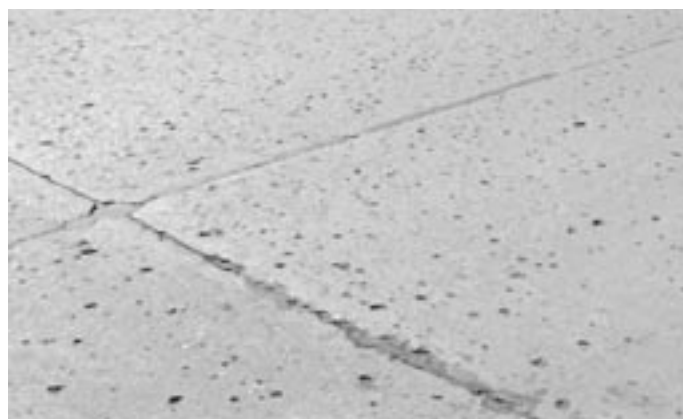
◀ **Hairline surface cracks, probably shallow in depth. May not cause any long term performance problems.**

◀ **Extensive pop-outs of large aggregate from surface. Pop-outs alone have not affected pavement serviceability.**

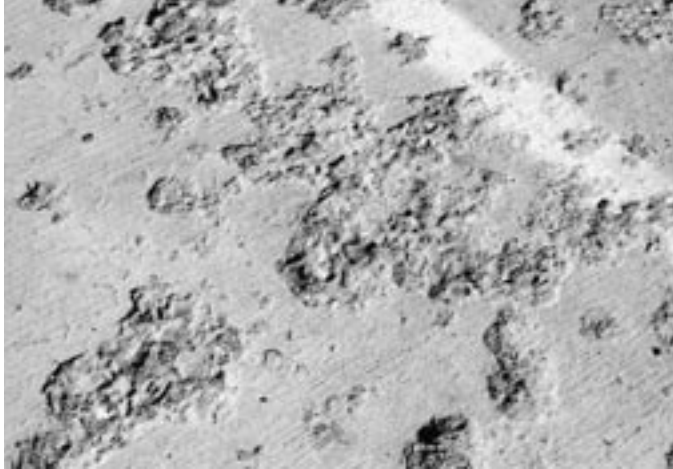
►  
Moderate  
surface scaling.  
Loss of mortar  
and fines from  
the surface  
beginning to  
expose larger  
aggregate.

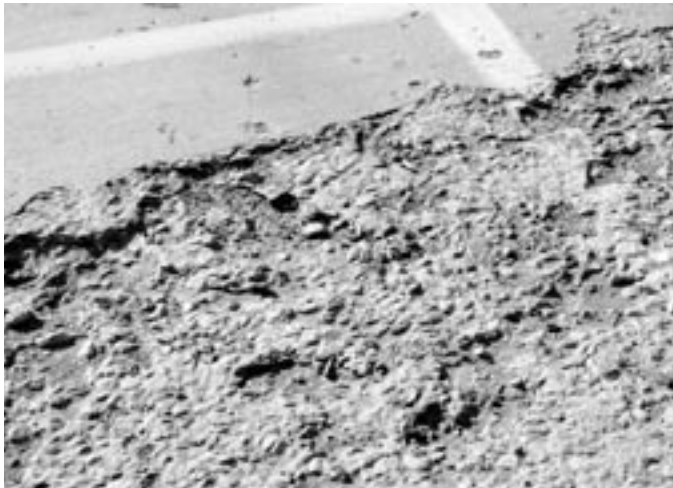
►  
Severe scaling.  
Some larger  
aggregate is  
loose.

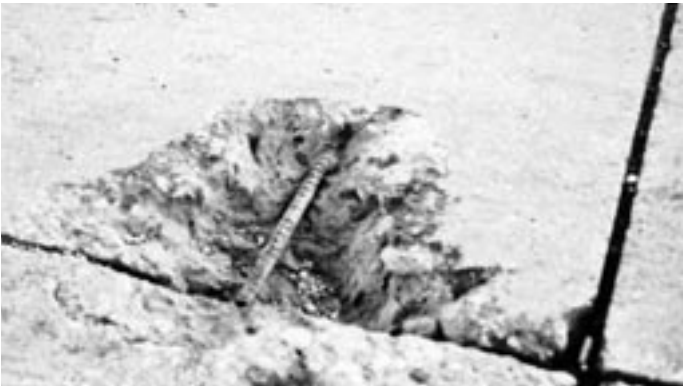
Reinforcing  
bar exposed.  
Shallow  
concrete cover  
caused large  
spall to develop  
around it.  
▼

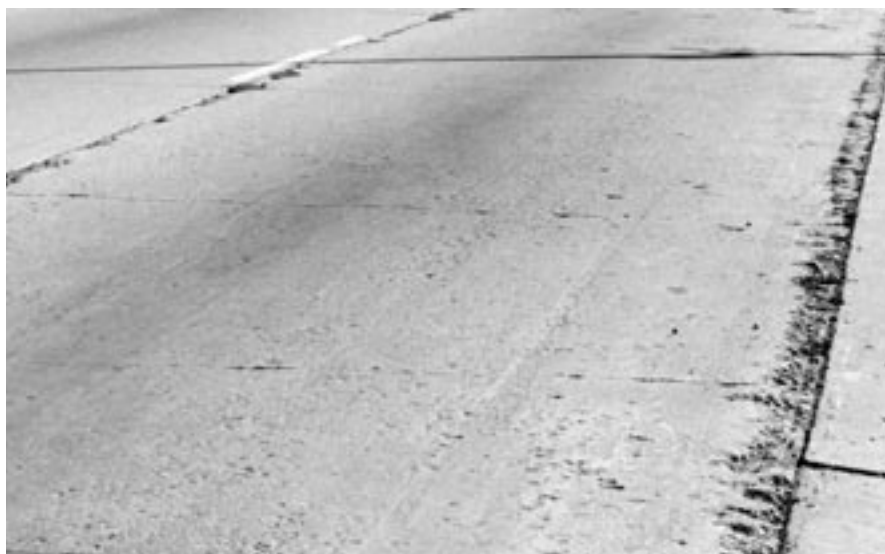
►  
Spalling along  
longitudinal  
joints.

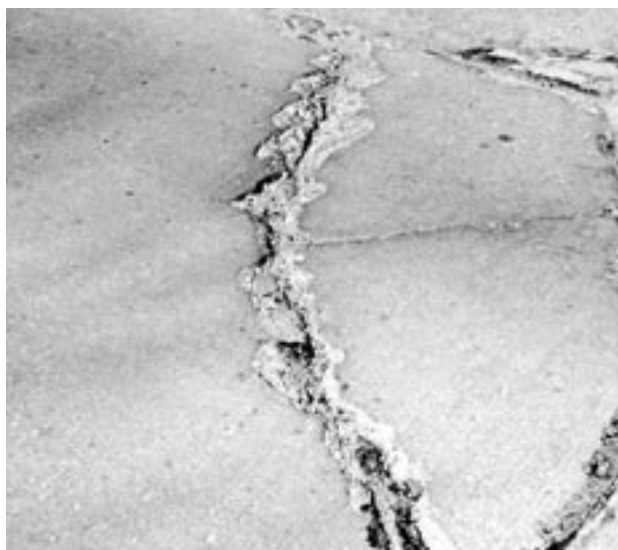
▼ A severely  
spalled crack.

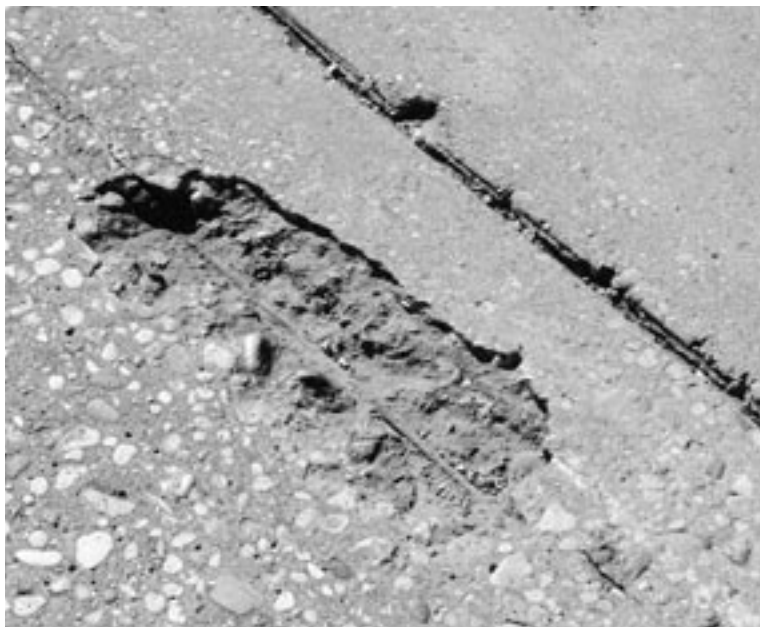
►  
Spalling over  
shallow reinforcing.

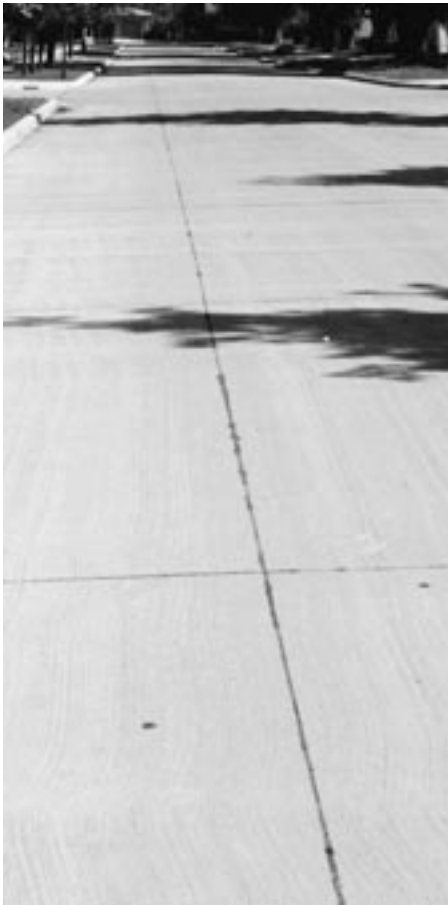
▲ Joint open about 1/2".

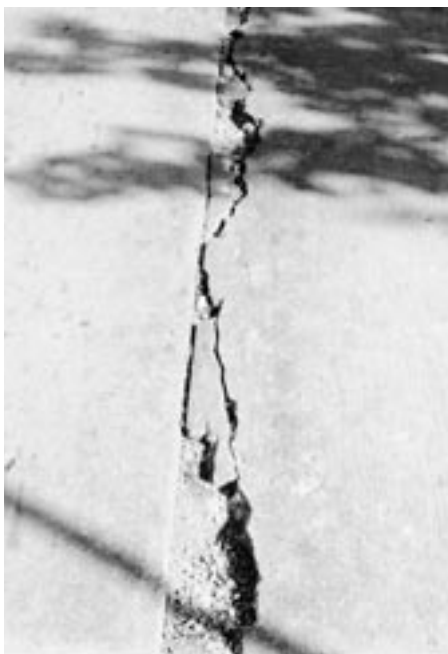
▲ Additional joint cracking, spalling, and broken pavement. Full depth repair is needed.

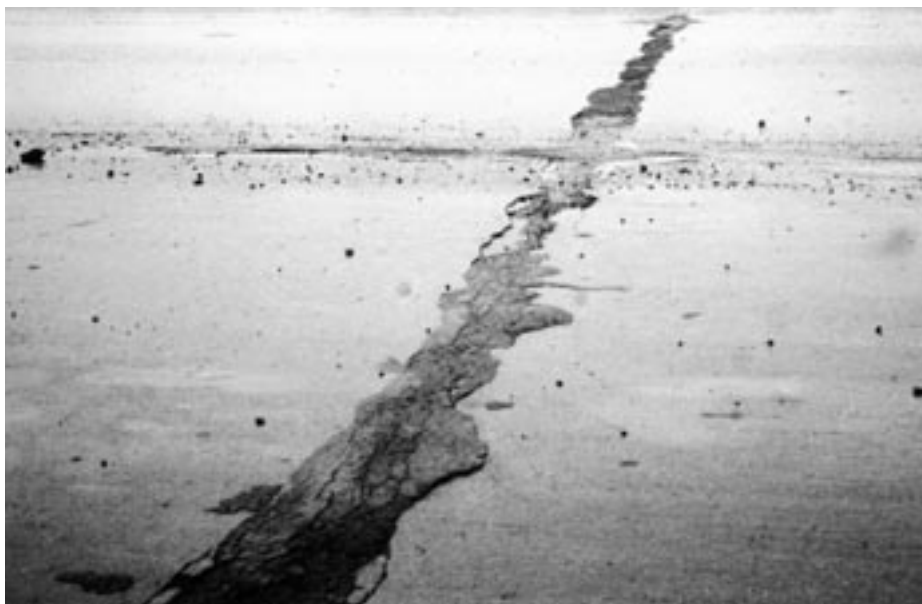
► Severe spalling has required temporary patching. Complete joint replacement is necessary.

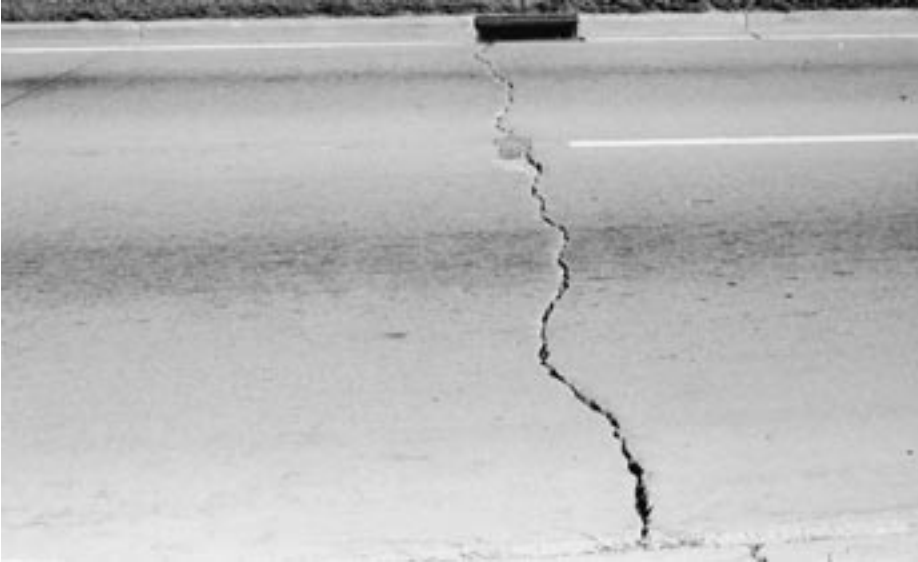
**Transverse,  
open crack.**

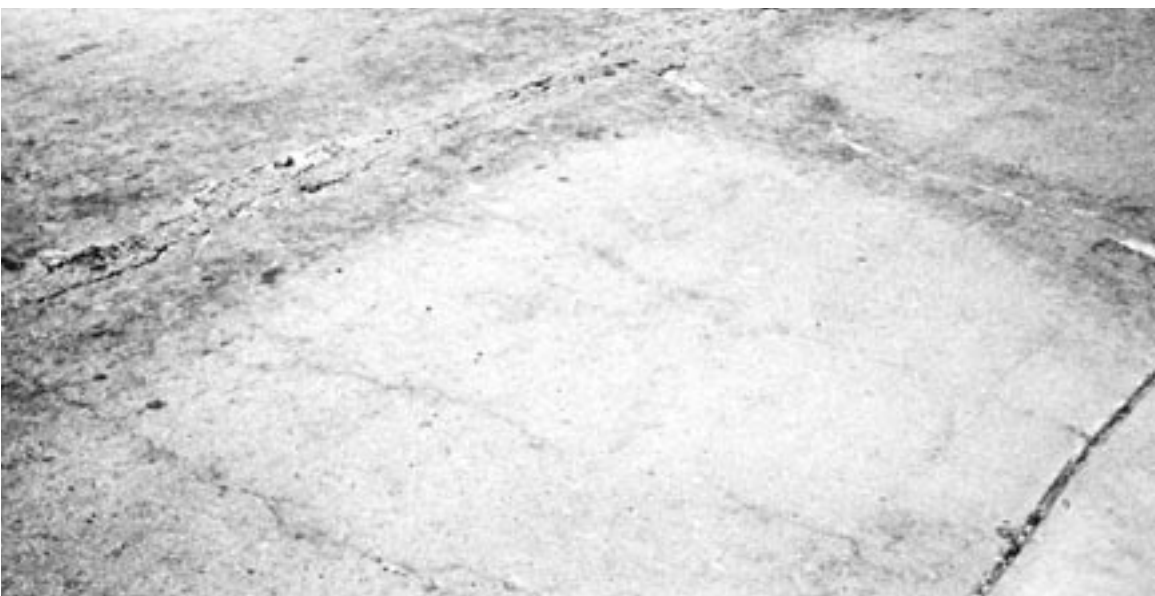
**Closely spaced,  
hairline trans-  
verse cracks.  
Indicates slab  
is broken  
and in need of  
replacement.**

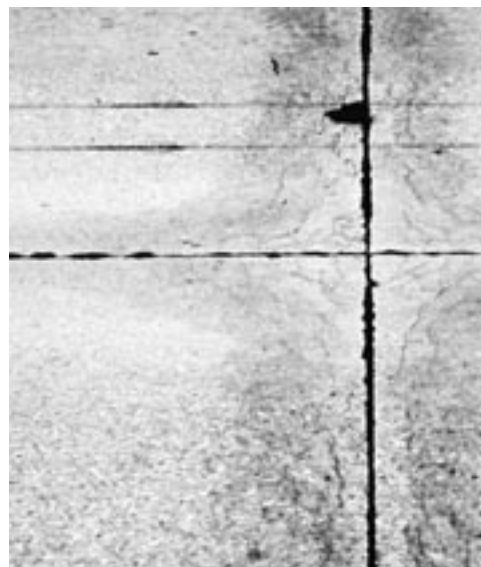
Surface discoloration near joints and cracks indicates D-cracking and severe slab deterioration.

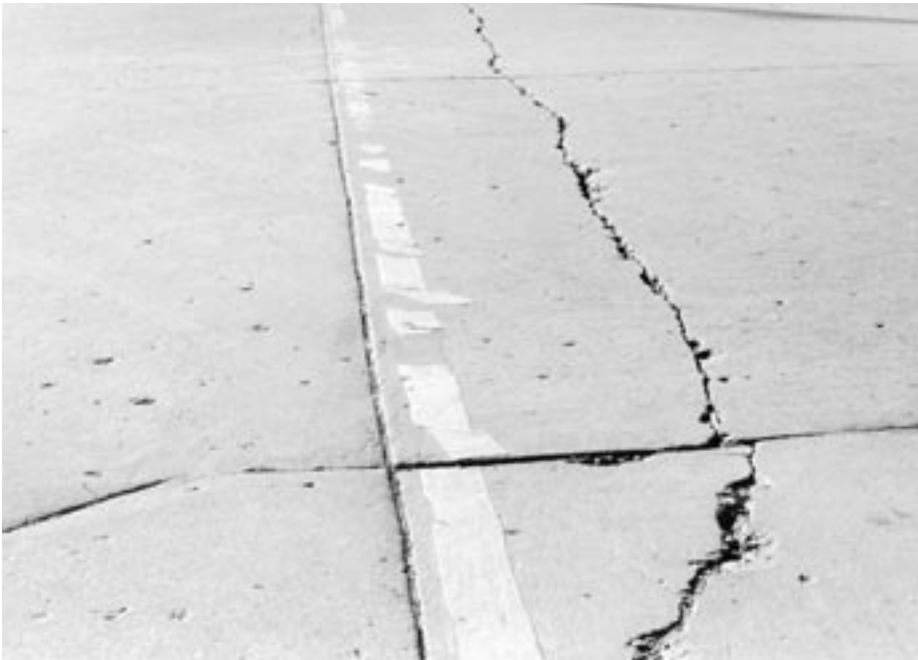
**Meander crack roughly parallel to longitudinal joint.**

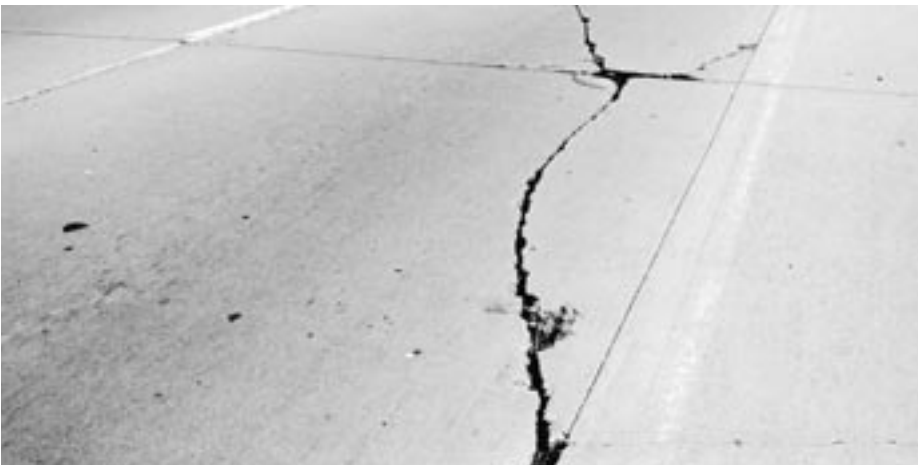
**Meander crack caused by settlement. Lack of maintenance allows water to intrude and debris to collect in crack.**

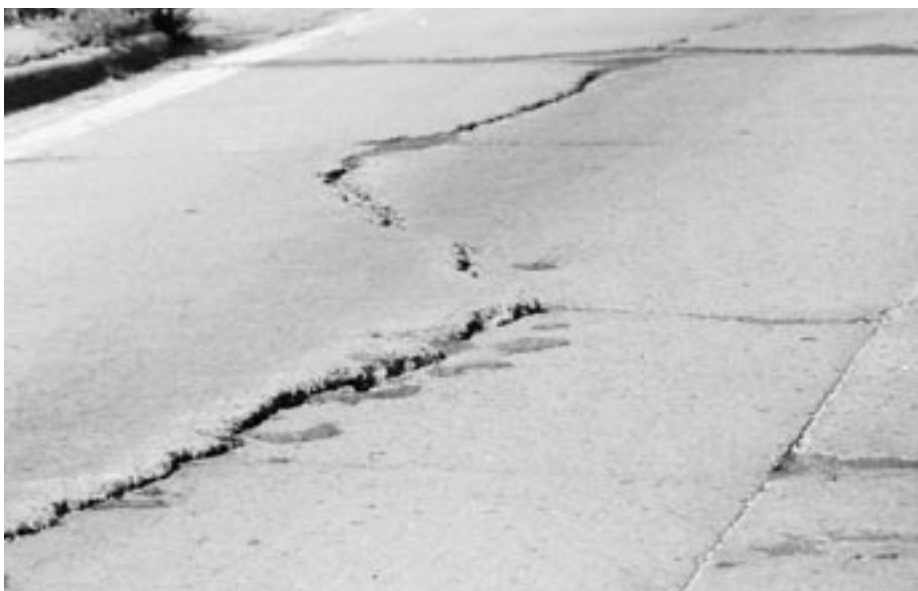
**Faulting and spalling of a meander crack.**

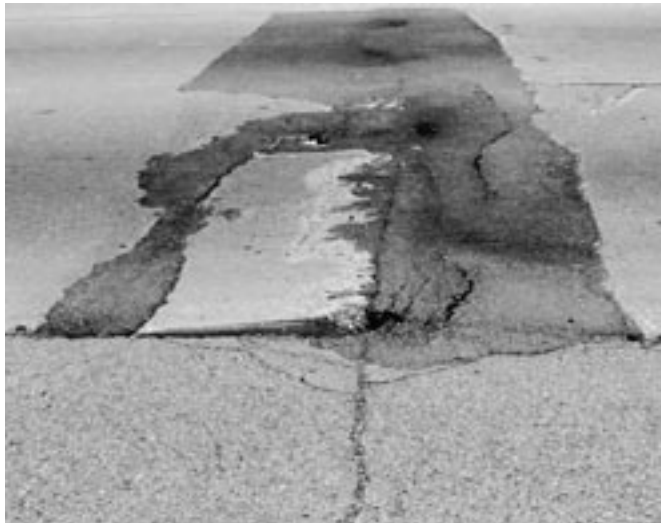
◀ Internal pressure has partially raised slab at the joint. Complete replacement is required.

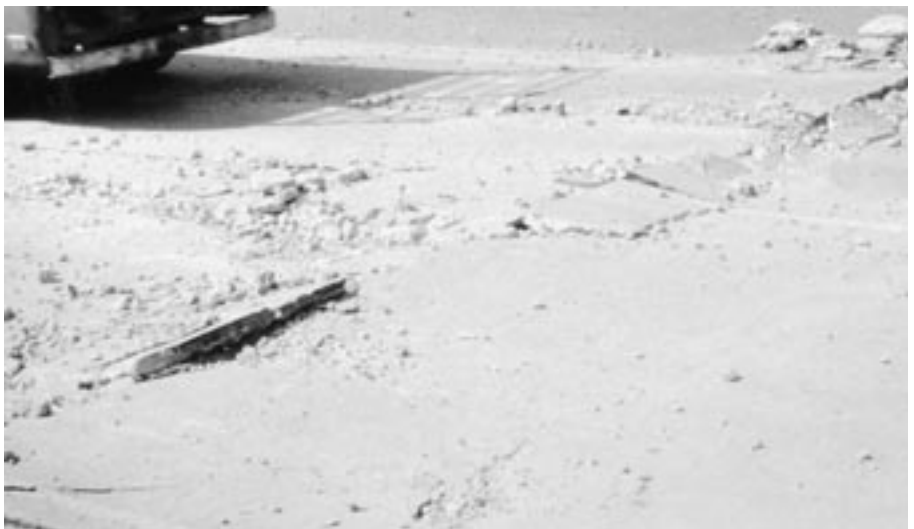
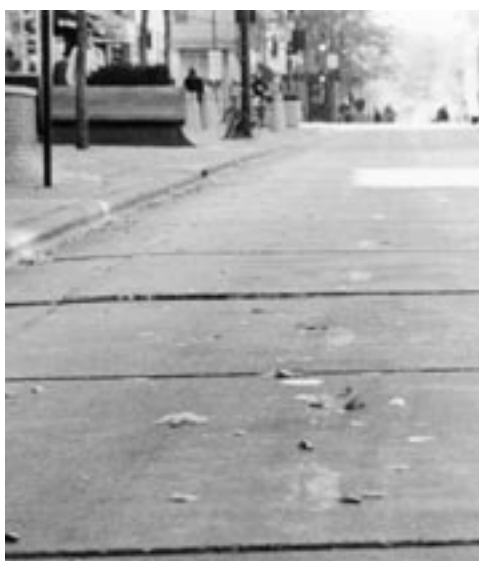
▲ Minor faulting of transverse joints. Aggravated by heavy traffic. Surface grinding will improve ride.

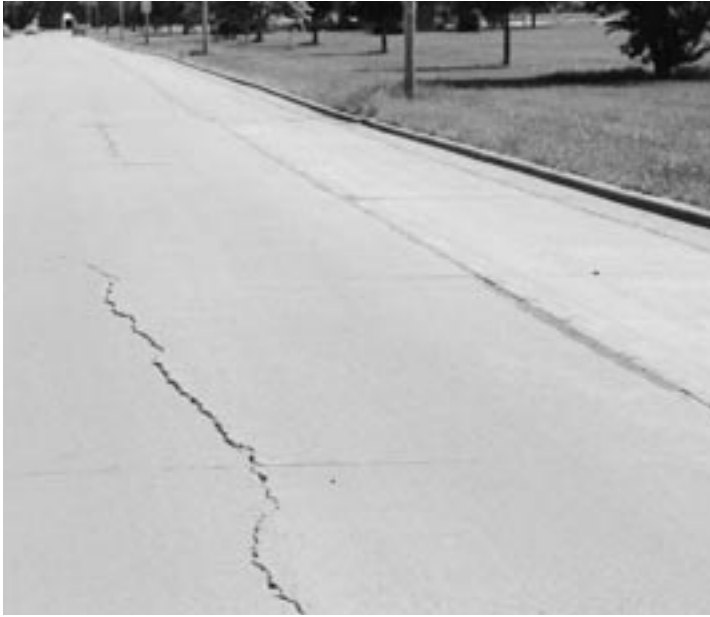
Extensive  
cracking and  
patching  
caused by  
settlement.  
Pavement  
was built on  
unstable sub-  
grade soils.

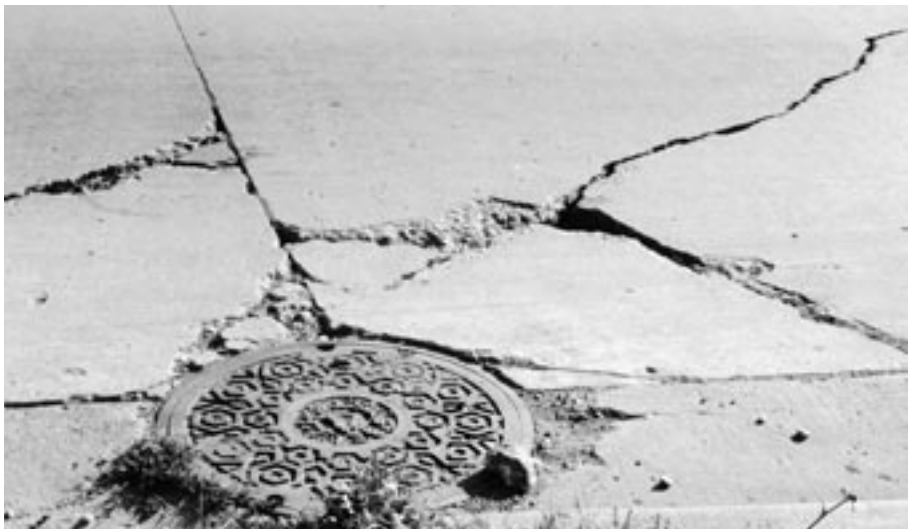
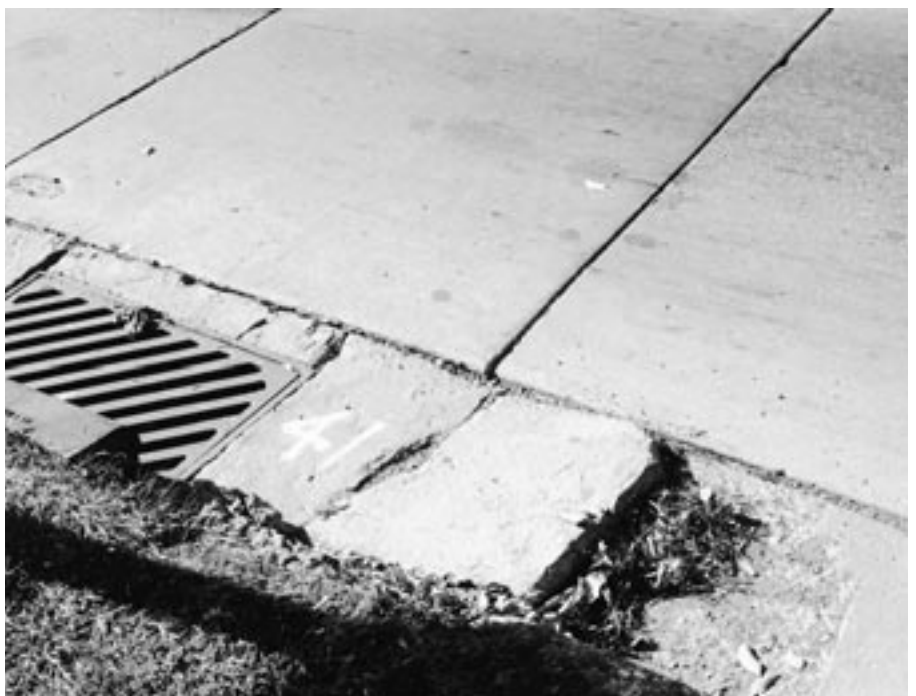
**Extensive cracking and spalling at manhole requiring full depth repairs. ▼**

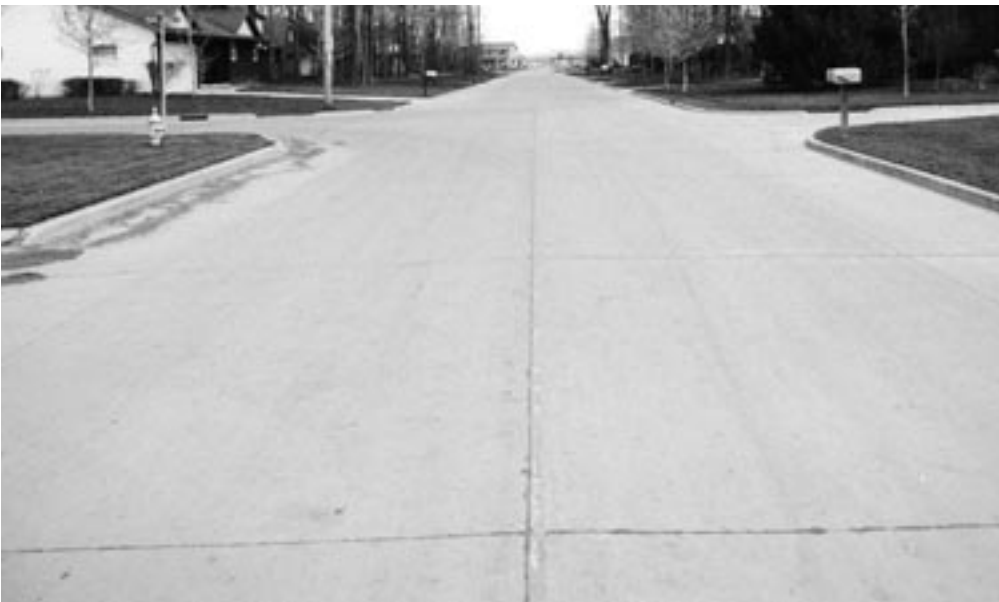
**RATING 10**  
New pavement  
with integral  
curb.

**COC Notes 10 -** No cracks, asphalt patches or partial depth patches. No displacement, scaling or popouts. May have minor imperfections in the original pouring of the slab (e.g. rough edges from surface scrapes, rounded corners that show no sign of continuing wear).

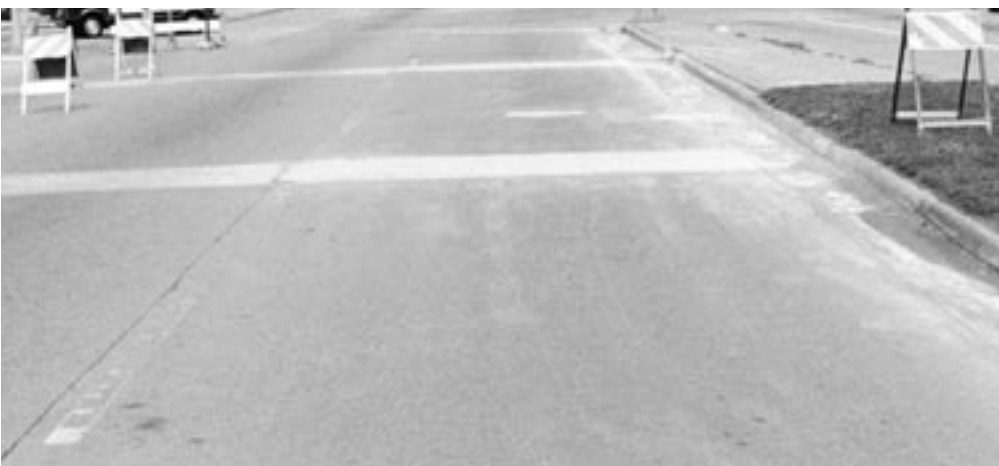
**RATING 9**  
Like new  
condition.

**COC Notes 9 -** The slab may have one minor hairline crack and no asphalt or partial depth patch. Minor imperfections are allowed such as minor scaling or few popouts. No raveling of the joints.

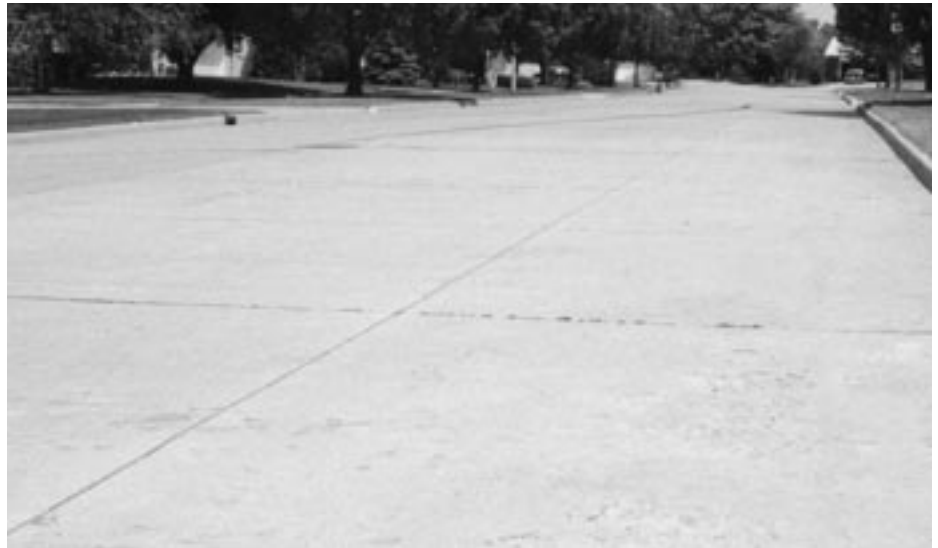
►  
Slight  
scaling.

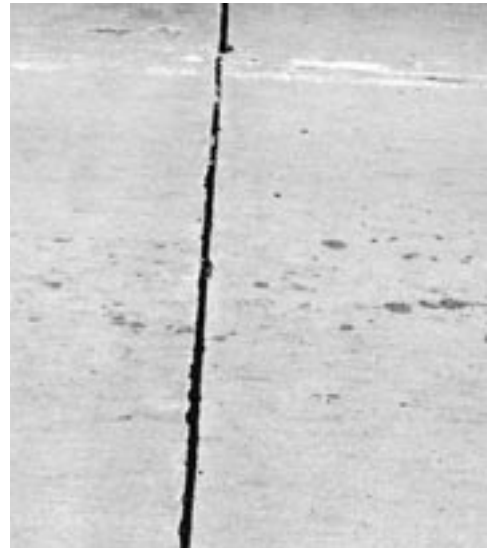
►  
Isolated  
spall at  
manhole.

▲  
Partial  
loss of  
joint  
sealant.

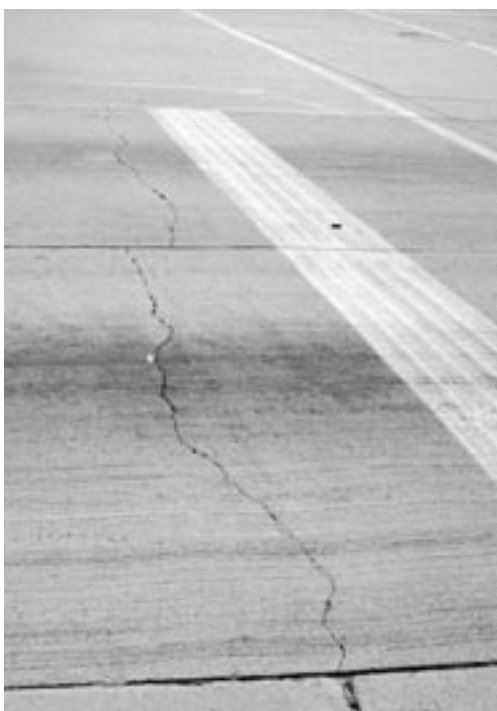
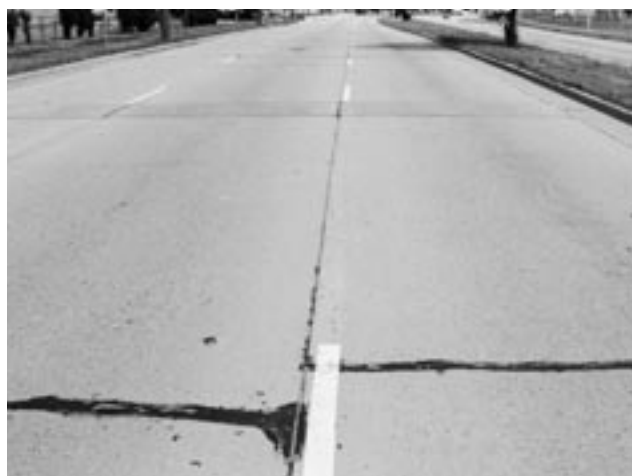
◀ **Recent full depth pavement repair. In very good condition.**

◀ **Well sealed transverse crack. Joint repairs in good condition.**

◀ **Transverse crack. Tight, sound pavement.**

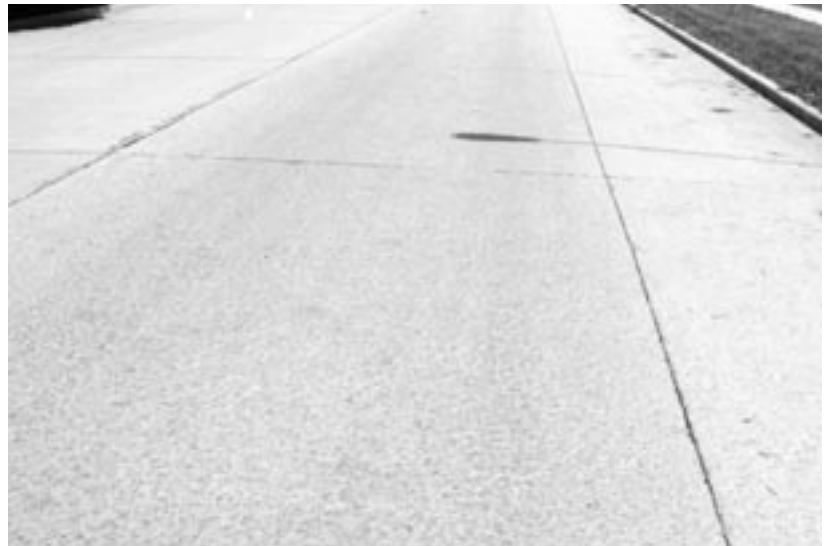
► Moderate scaling.

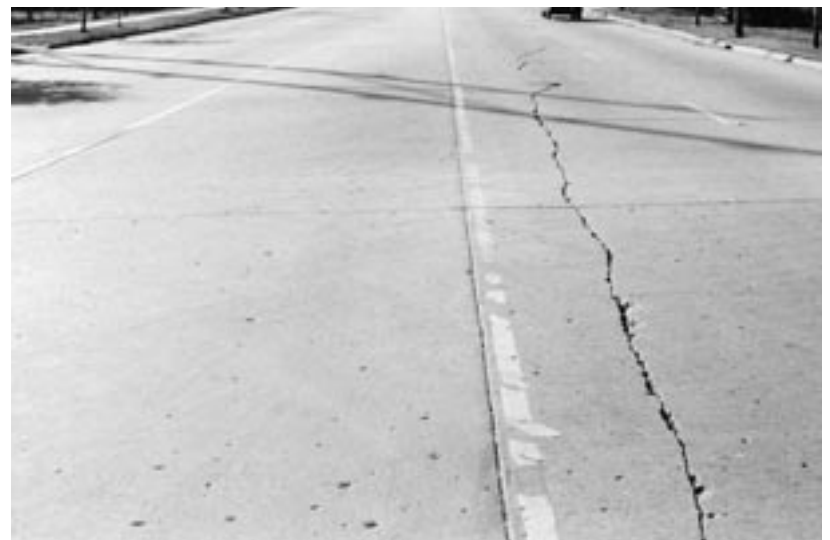
▲ First signs of corner cracks.

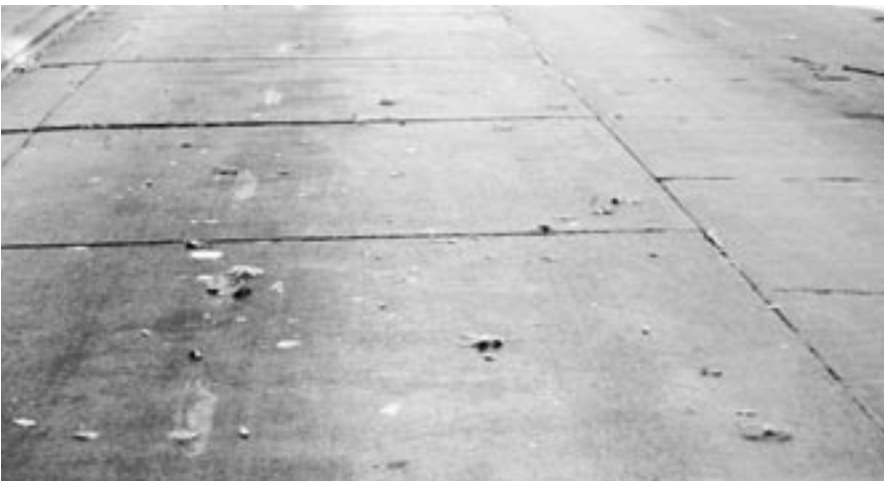
**Faulting at longitudinal joint and spalling along joint edge.**

**COC Notes 5 - Slab is cracked into more than 3 sections. Asphalt patches at the joints are more than 3" wide. Partial depth patches are failing.**

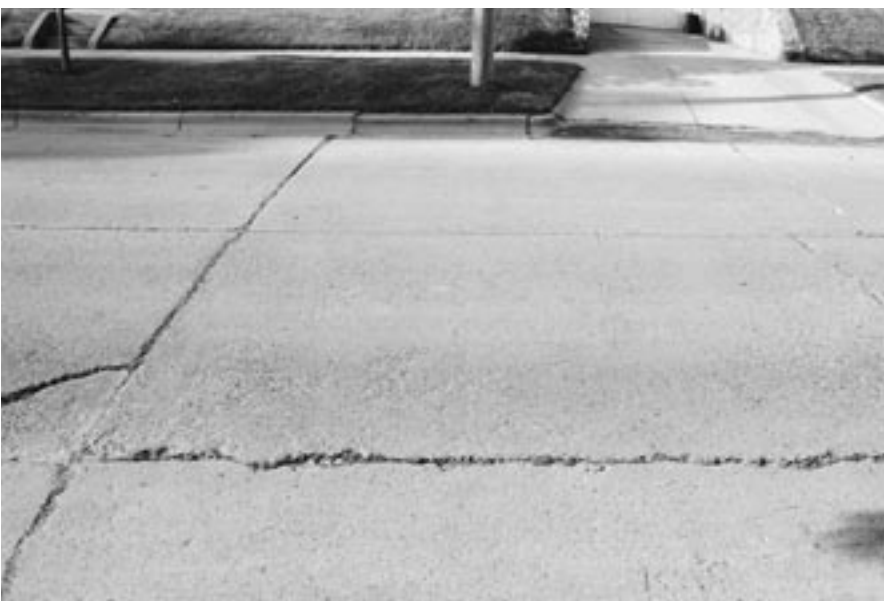
**First signs of transverse joint faulting. Grinding will improve ride.**

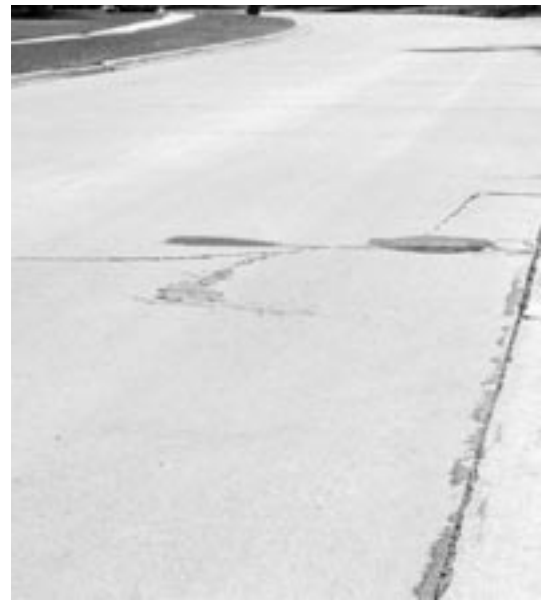
▲ **Open cracks with edge spalling. Corner crack and broken corner piece.**

▲ **Isolated manhole problems and joint spalling. Full depth repair required adjacent to manhole.**

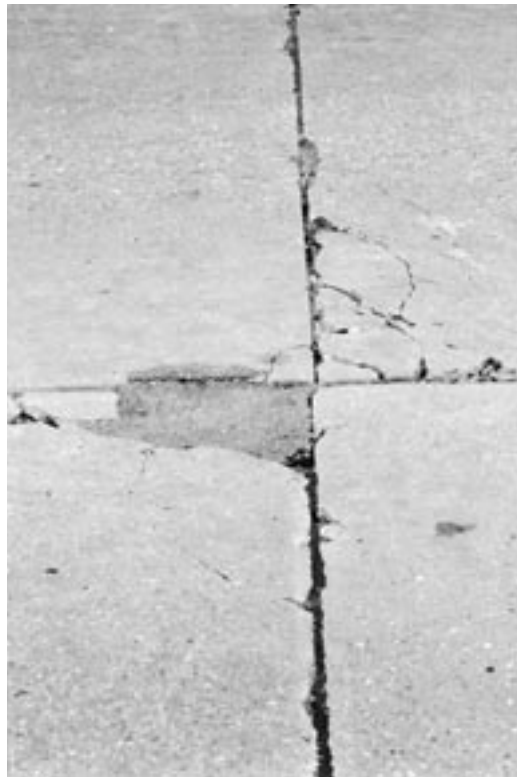
► Broken corner  
pieces. Some  
joint spalling.

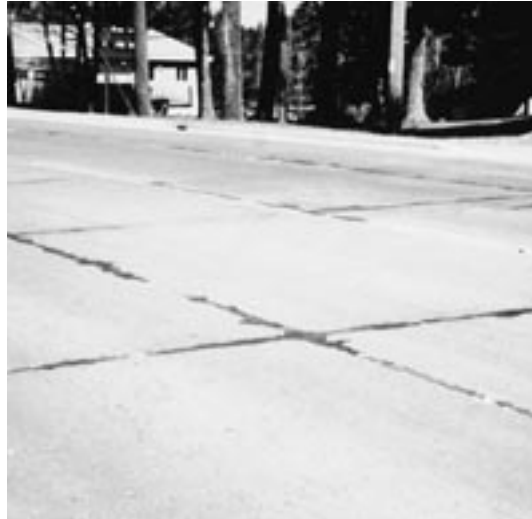
▼ Corner crack with spalling.

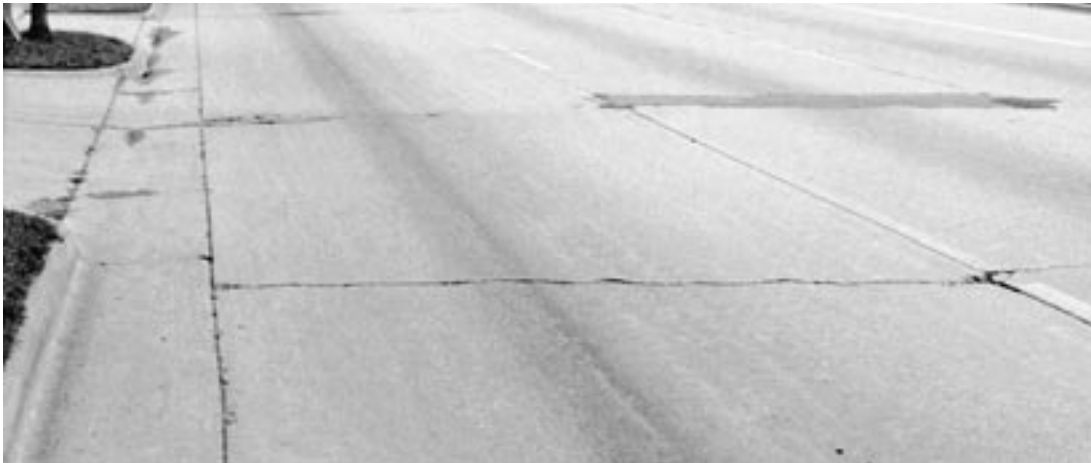
All joints show some deterioration and spalling.

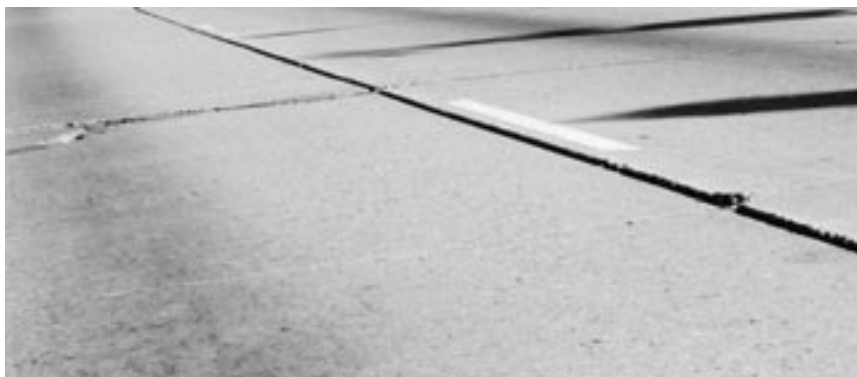
▲ Corner cracking developed into small hole; moderate spalling of transverse crack.

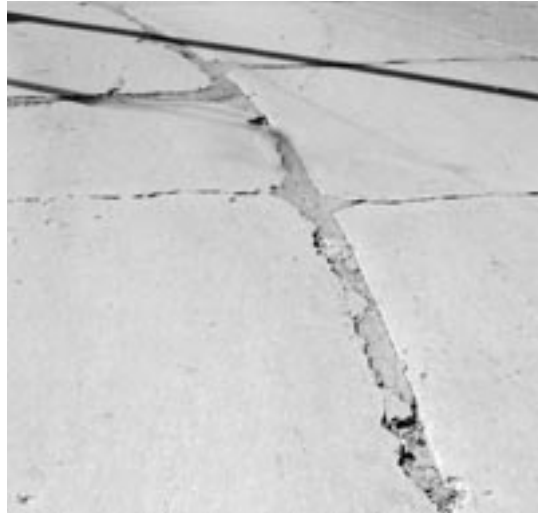
► Joints and cracks badly spalled. Patching is failing. Full depth repairs required.

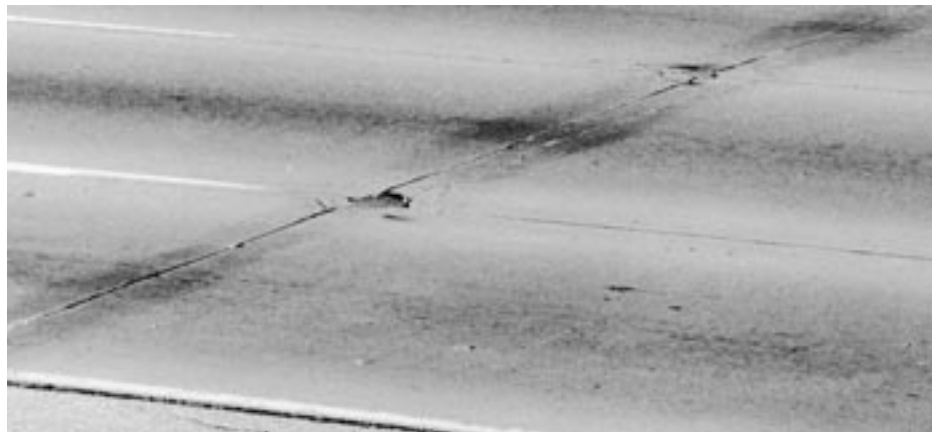
► D-cracking (discoloration) at transverse joint and corner cracking. Needs full-depth repair.

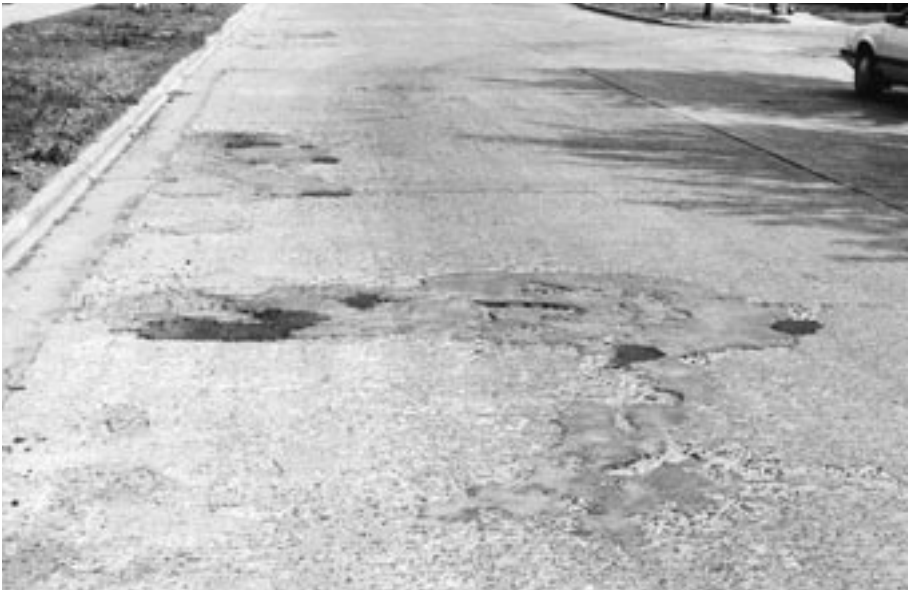
◀  
Failed patches.  
Replace entire  
portion of lane.

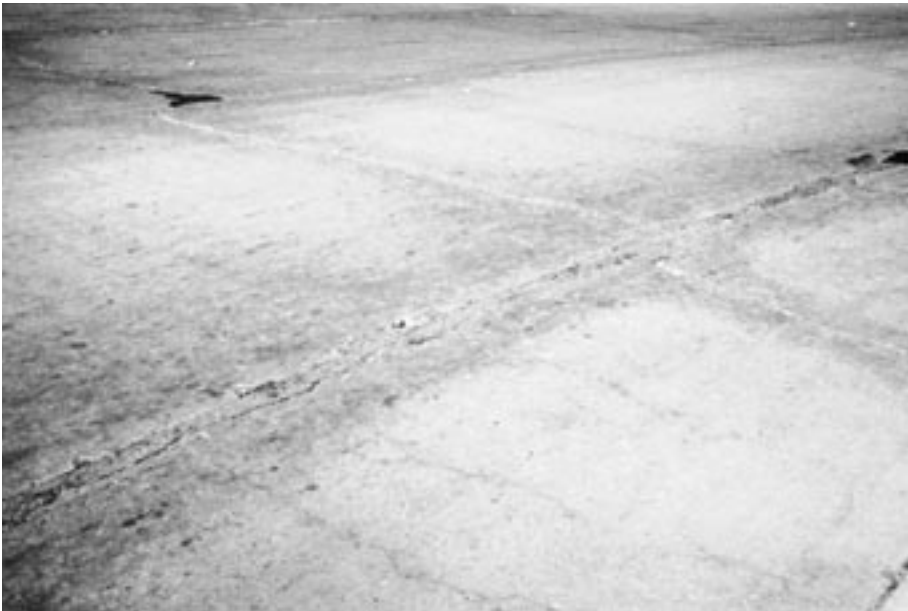
▲ Remove and replace  
pavement around  
manhole and inlet.

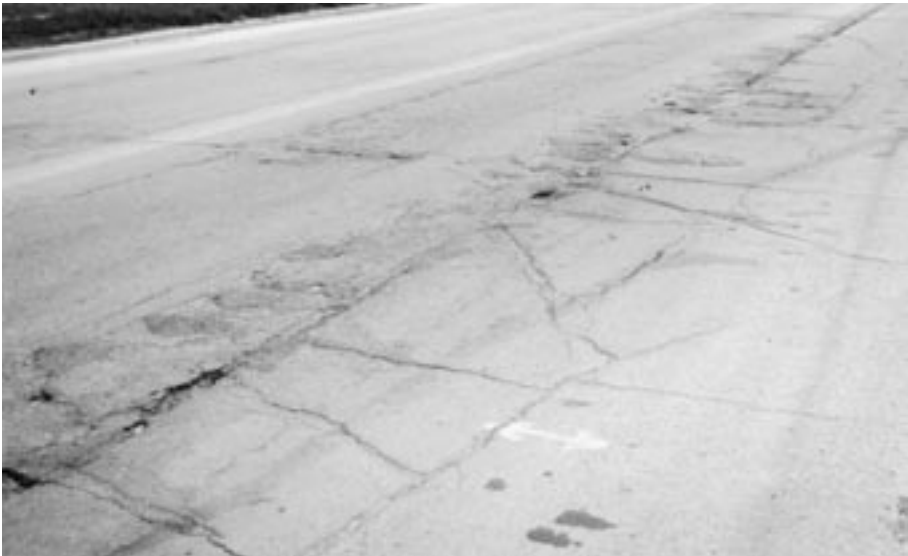
▲ Extensive joint  
failure. Major  
rehabilitation or  
complete replace-  
ment needed.

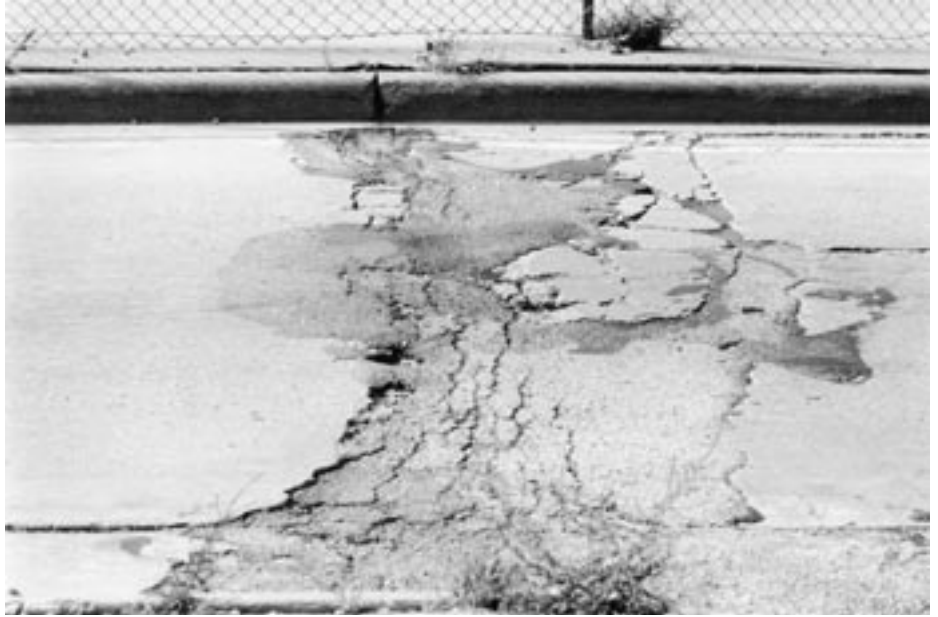
►  
Slab and patch failure.

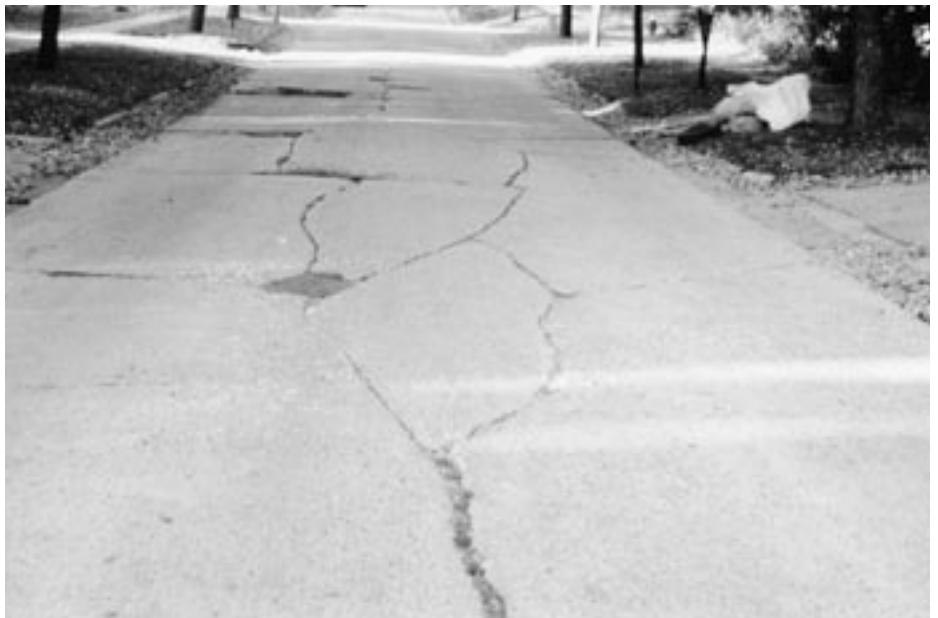
►  
Broken slabs require complete rebuilding.

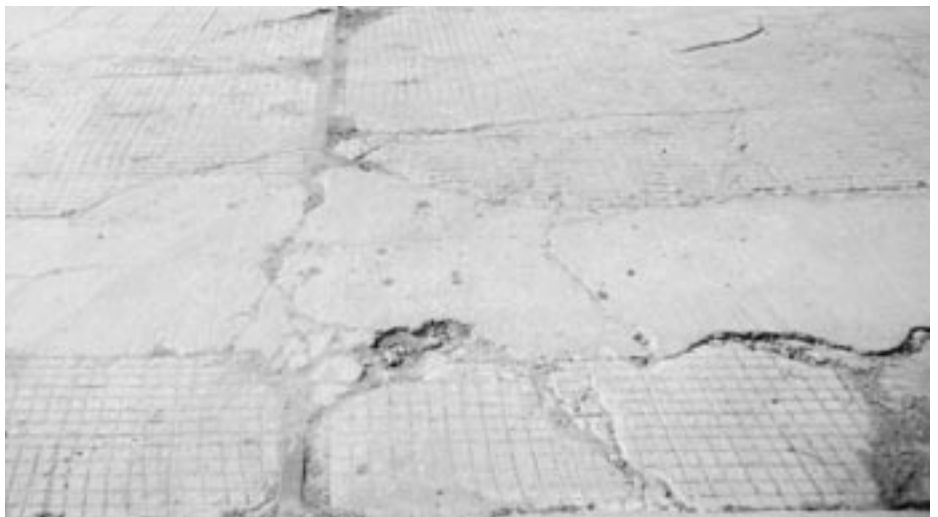
►  
Total failure.

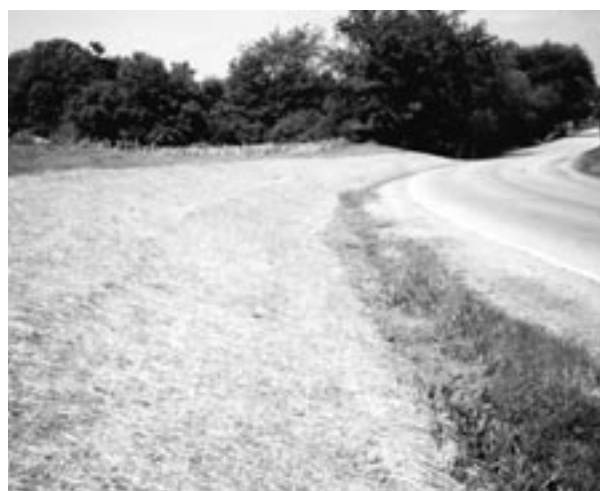
### ▼ Urban drainage. RATING: Excellent

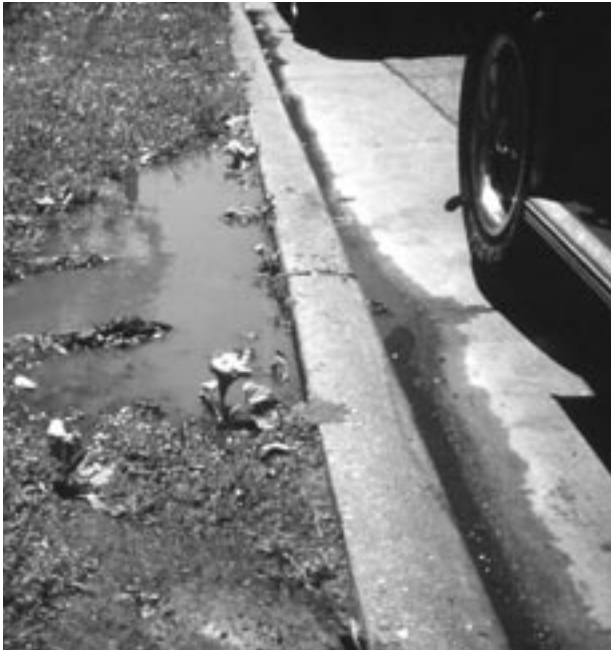
▲ Reshape terrace behind curb to restore drainage and prevent damage to curb and street.

**RATING: Fair**

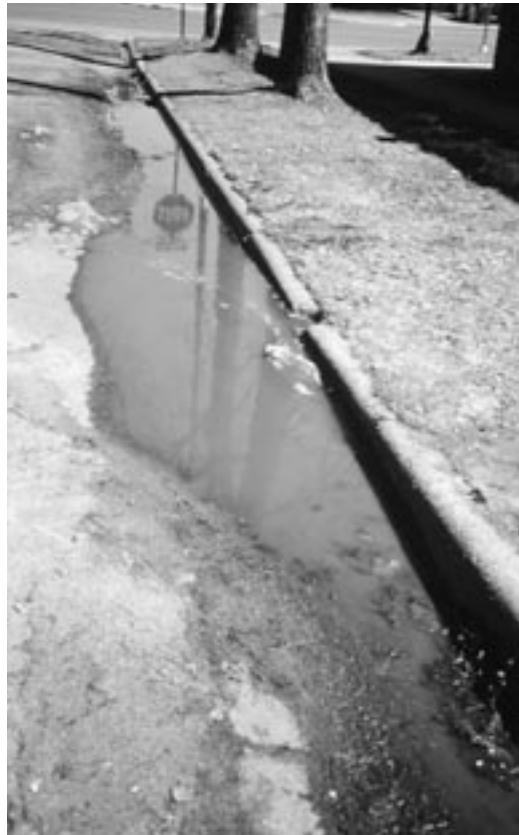
► Flooding. Curb and gutter need reconstruction.

**RATING: Poor**
