**CITY OF CHESTERFIELD  
PLANNING AND PUBLIC WORKS COMMITTEE MEETING**

**C. 2026 Concrete Pavement Manual**

This annual Concrete Pavement Manual focuses on the City's concrete roadways and aims to assist Staff with budgeting, project planning, maintenance prioritization, and long-term infrastructure preservation. This Report contains a detailed analysis of the City's concrete pavement inventory, inspection methodology, current conditions, historical performance, and future budget scenarios.

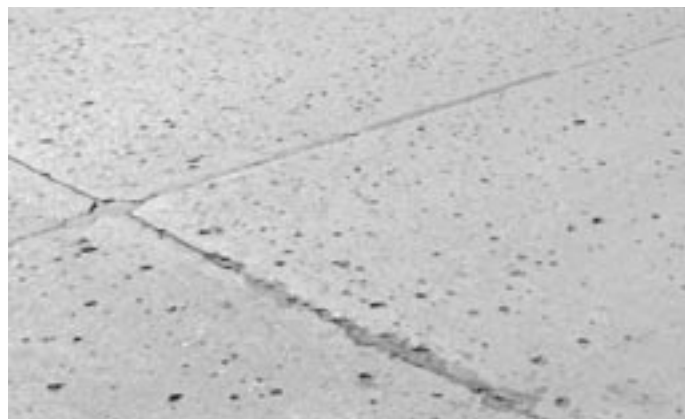
◀ **Extensive pop-outs of large aggregate from surface. Pop-outs alone have not affected pavement serviceability.**

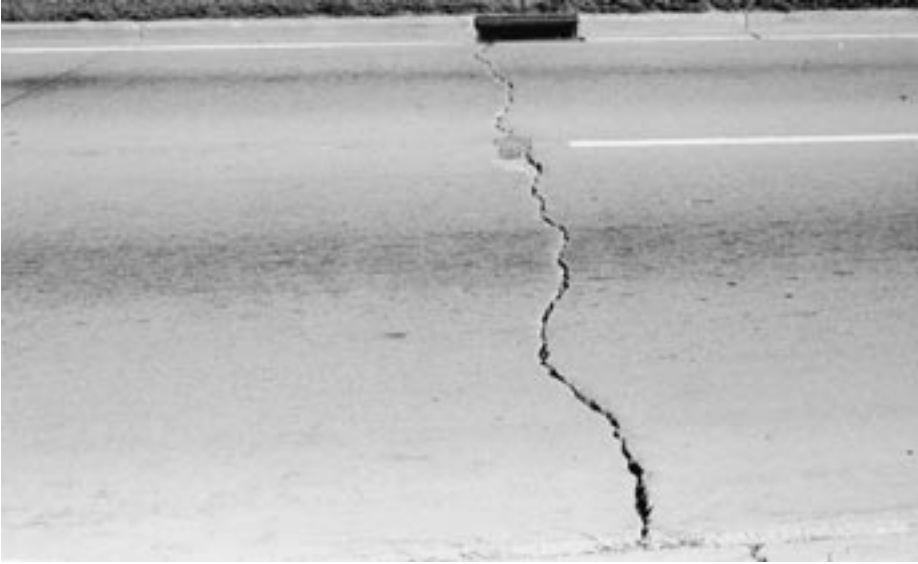
**Faulted transverse  
crack with slight  
edge spalling.**

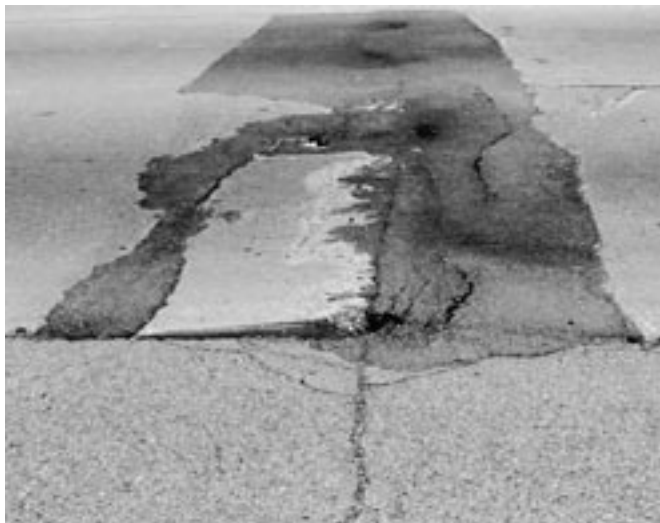
◀ Internal pressure has partially raised slab at the joint. Complete replacement is required.

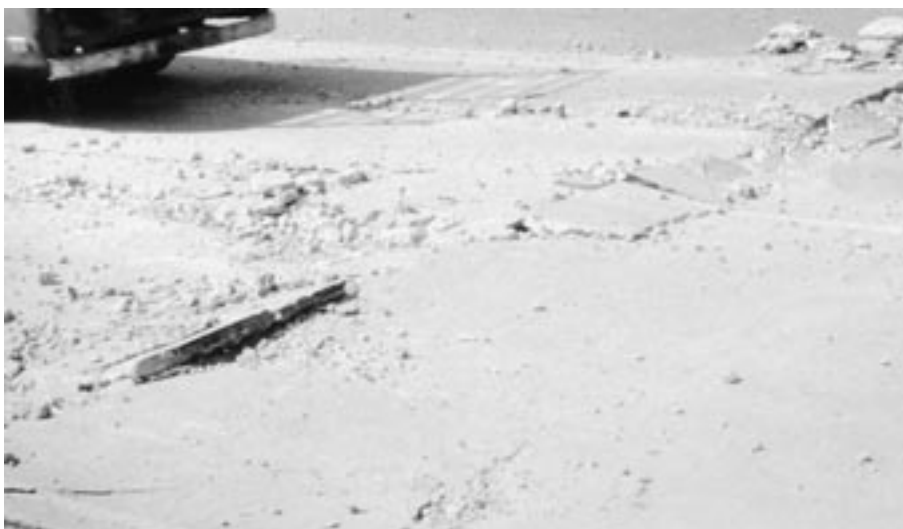
▲ Minor faulting of transverse joints. Aggravated by heavy traffic. Surface grinding will improve ride.

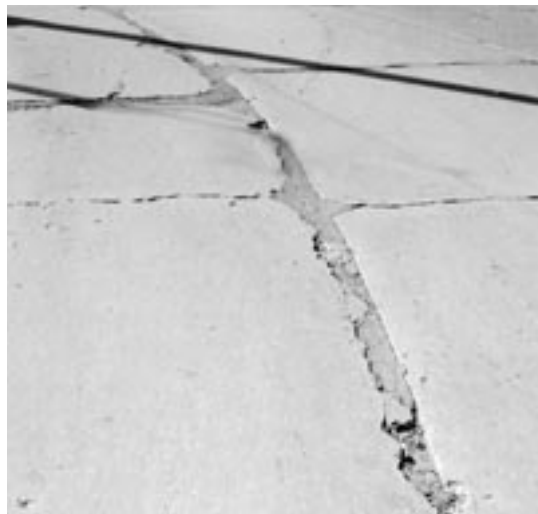
► Joints and cracks badly spalled. Patching is failing. Full depth repairs required.

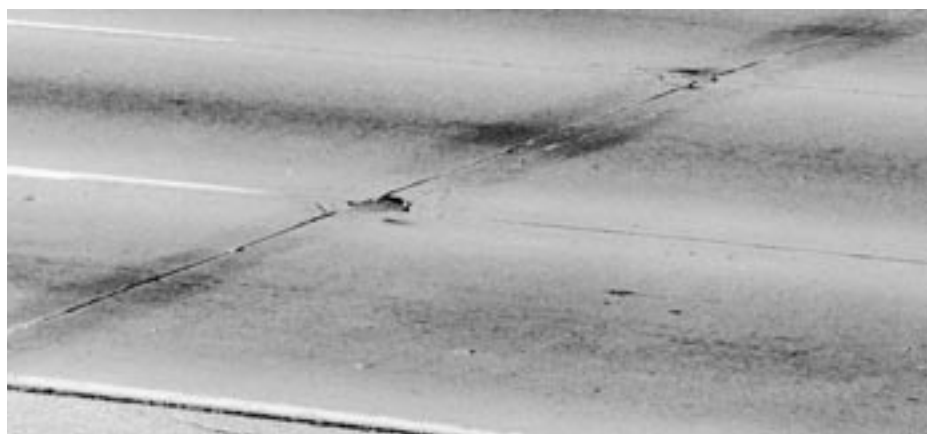
► D-cracking (discoloration) at transverse joint and corner cracking. Needs full-depth repair.

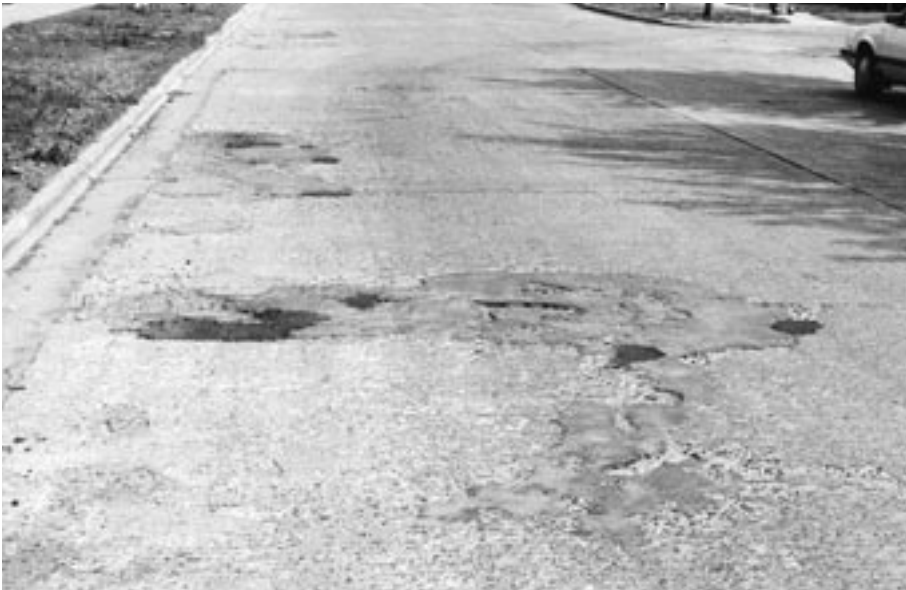
◀  
Failed patches.  
Replace entire  
portion of lane.

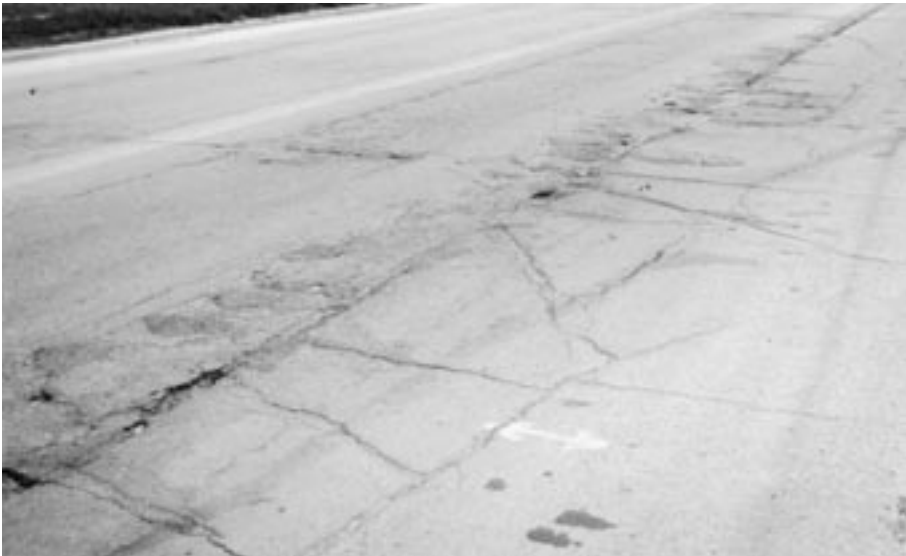
▲ Extensive joint  
failure. Major  
rehabilitation or  
complete replace-  
ment needed.

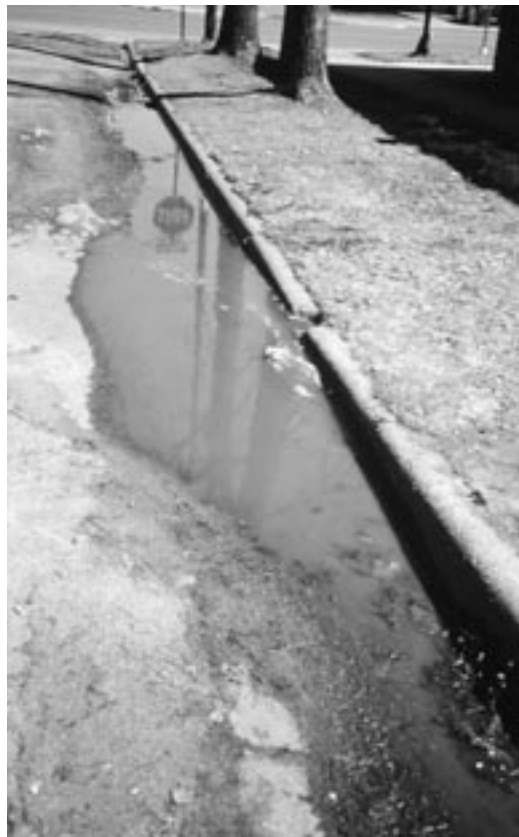
► Flooding. Curb and gutter need reconstruction.
